03.07.13

# A Renovation to 480 Grand

## Phase 1

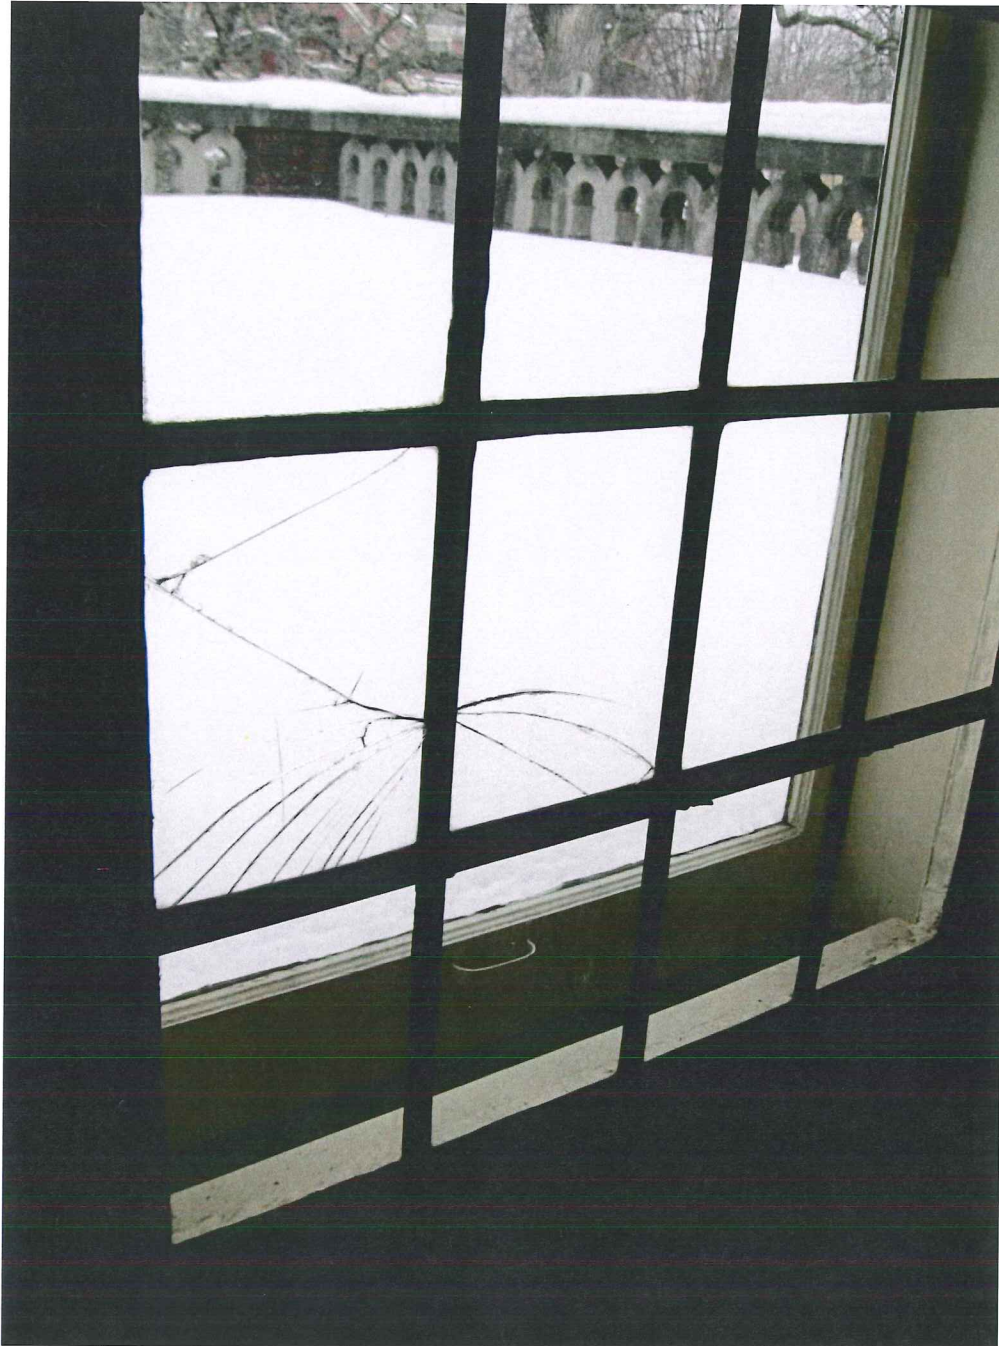
Stair Landing Window Damage

- Repairing the metal framed windows at the Stair Landing. Two of the existing pains have been severely damaged and need replacement. We propose to repair the damage and install a 3mm safety film over all the pains of the eight units in that area. This will require the units to be removed, reconditioned and reinstalled.

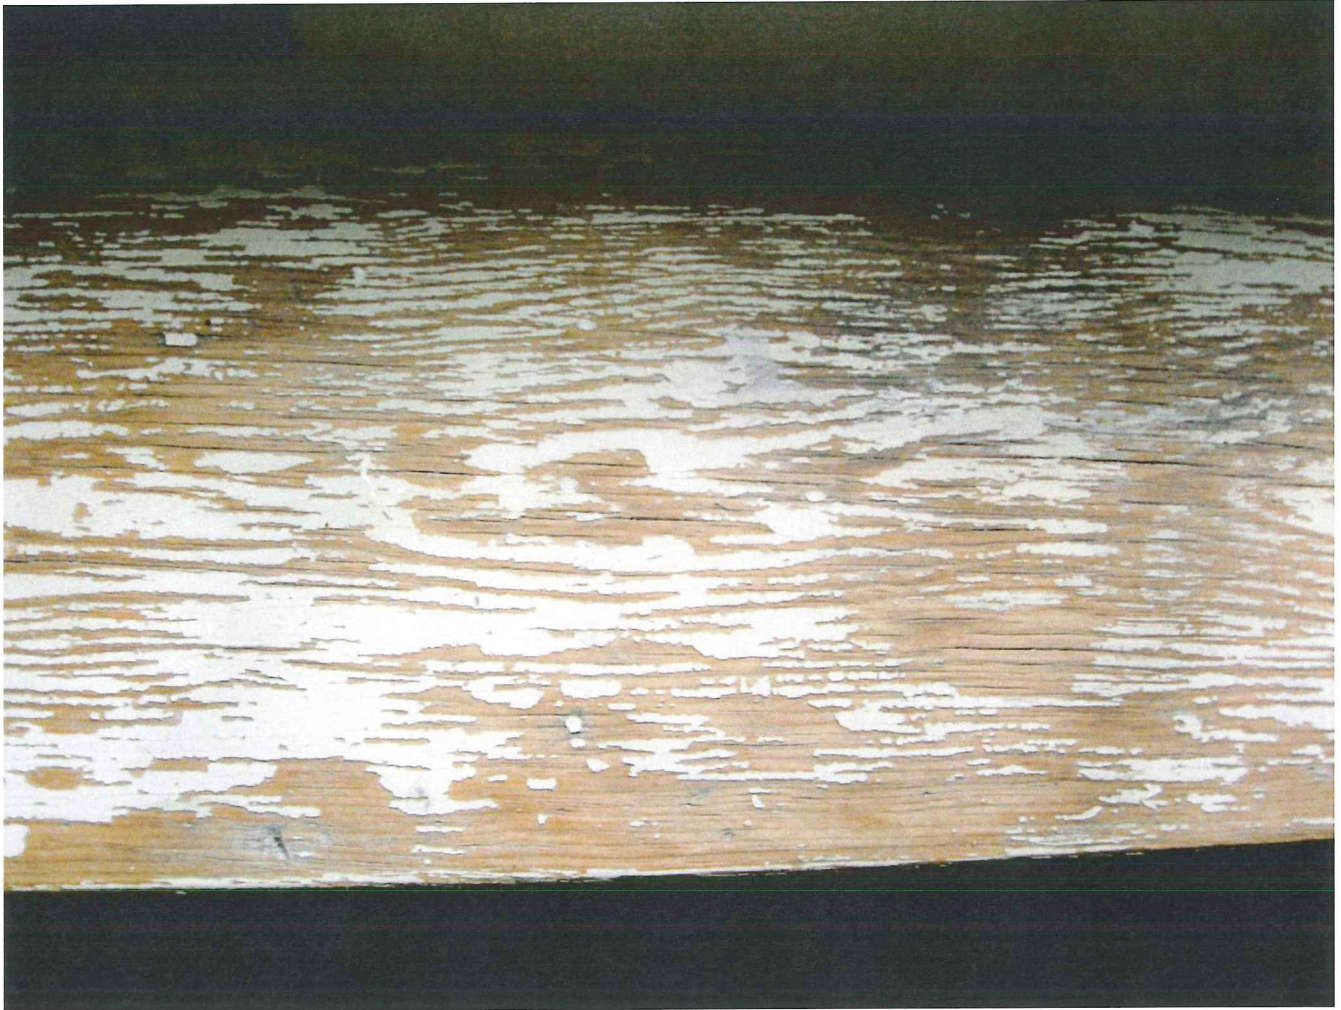
Typical Condensation Damage

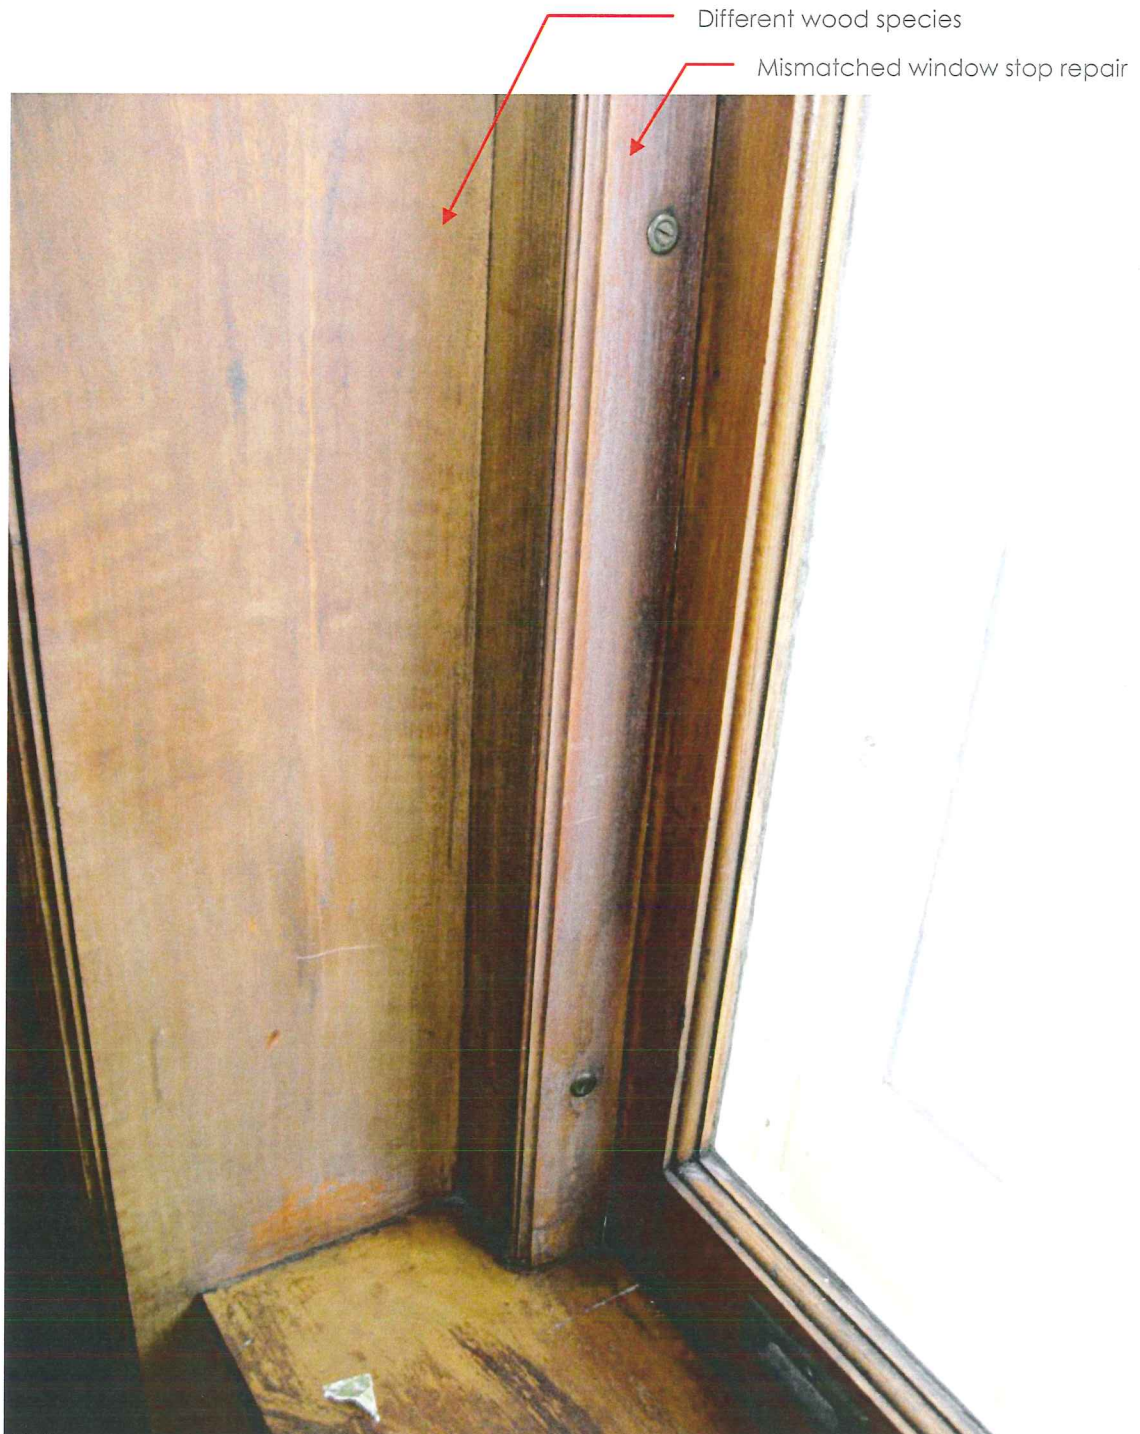
Living Room Window Mismatched Repair

Metal glide indicated previous replacement

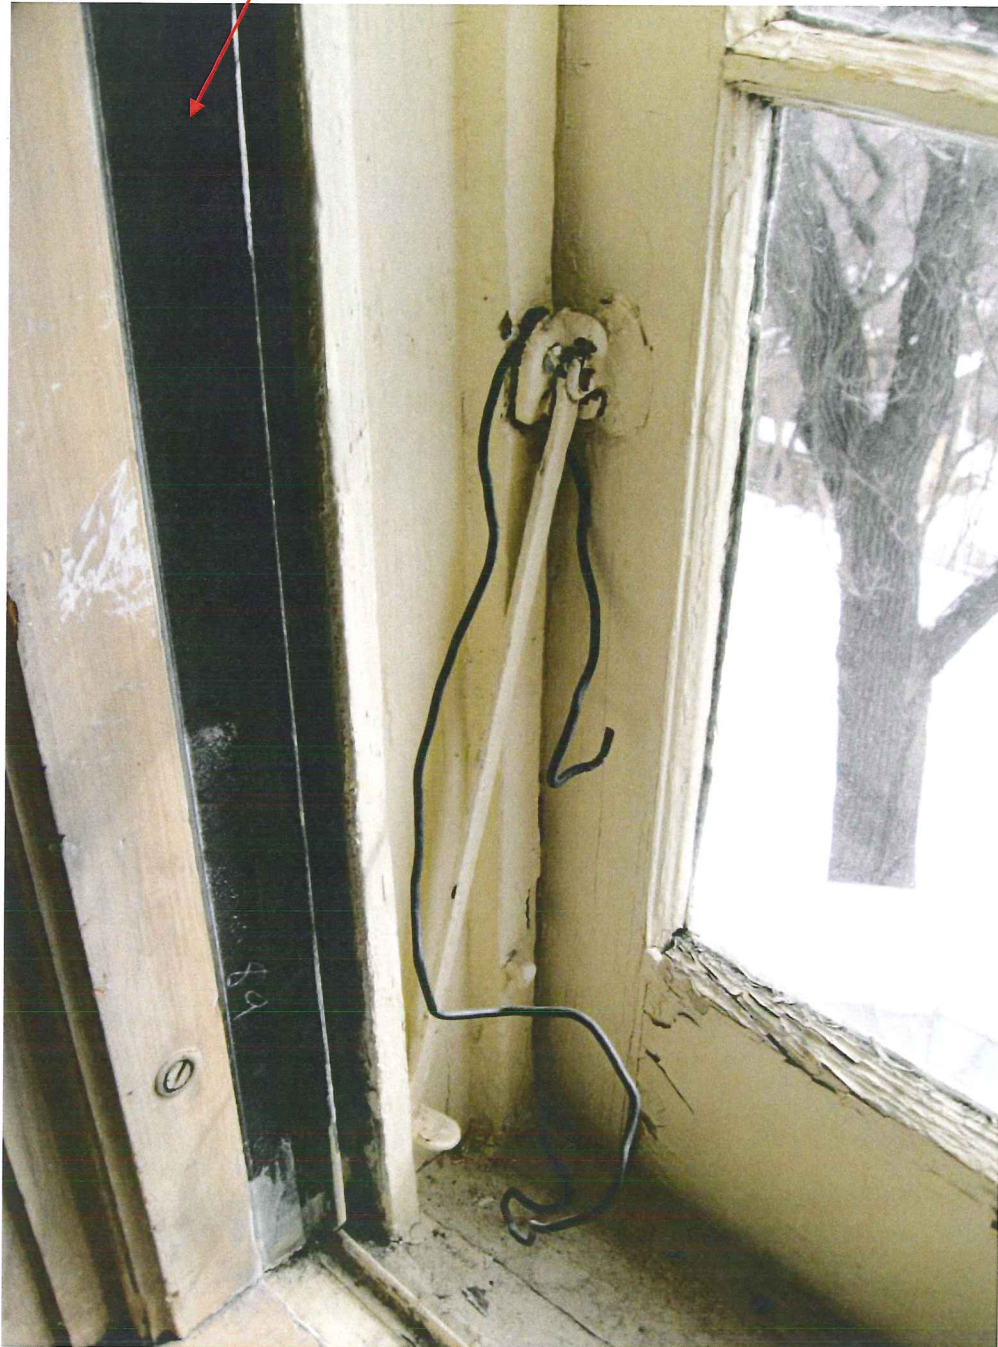
Faulty Repair to Previous Replacement Window (Third Floor)

- Replacing all of the Third Floor windows. Neglect and poor previous repairs have left nearly all windows leaking water. Airflow can be felt around the window sashes and thermal inspection shows massive air leakage. We are proposing replacing the current units with custom sized (to match) windows manufactured by Marvin Windows of Warroad, MN. Each unit will be wood framed, Authentic Divided Lites (ADL) with safety glass for security purposes.
